**Flood Control Project Maintenance  
Levee Inspections**  
**LMA District Cover Sheet**  
**Spring 2018 Levee Inspection Results**

**City of Sacramento**

**Spring 2018 Levee Inspection Results**

Waterway			Bank	Unit Miles
Unit No. 01 Sacramento River			Left	3.67
	Spring (March - May)	Summer (June - August)	(September - November) Fall	Winter (December - February)
Unit Maintenance Rating (Fall Only)				
Date of Inspection	3/20/2018 - 3/20/2018			
DWR Inspector	Zach Jojola			
Accompanied By	Adam Strebel City of Sacramento

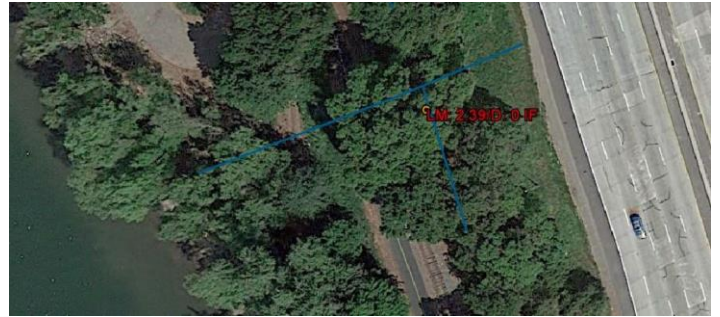
Photo 1 of 1 : UCIP\_SP\_2018\_41433\_72801.jpg

LM Start	2.39	Rating **	M	Issue No.	158
LM End	2.39	Issue Type +	En	Location *	
Category	Supplemental			GPS Latitude/Longitude	
				Start	End
Item	DWR UCIP Field Study			38.558793 °	38.558793 °
				-121.514460 °	-121.514460 °
DWR ID					
Comment Code					
Inspector Comment					
FS_ID:41433 DS_ID:24926 EP_NO: N/A Repair Type: Non-Urgent Crossing Status: Indicator Found UCIP Comments: 07/21/2016 Meet with City of Sacramento North Area Drainage representatives: Mick Smith and Mike Gonsalves. No additional information was provided by LMA. (DWR UCIP – O. Magana) 03/06/2013 Need to coordinate with owner to determine status of crossing. Unable to find crossing in the field. (DWR UCIP - O. Magana) FIELD_STRUCT_DESC: Drainage pipe of unknown size through levee at an unknown depth below the levee crown. Crossing information was obtained from Sacramento County GIS records. FS Date: 3/6/2013

Approximate alignment for crossing provided by City of Sacramento GIS.

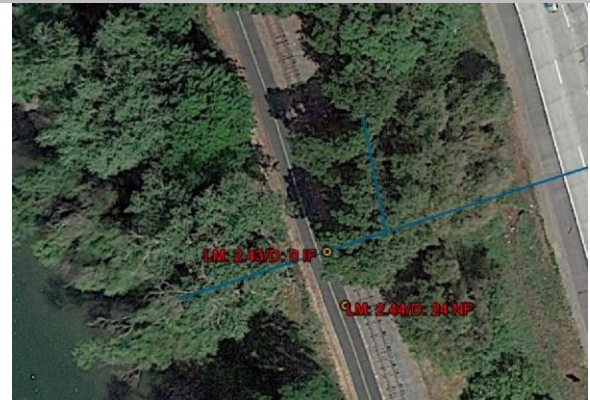
Photo 1 of 1 : UCIP\_SP\_2018\_41296\_72767.jpg

Comment Code						
Inspector Comment						
FS_ID:41296						
DS_ID:24927						
EP_NO: N/A						
Repair Type: Non-Urgent						
Crossing Status: Indicator Found						
UCIP Comments: 07/21/2016 Meet with City of Sacramento North Area						
Drainage representatives: Mick Smith and Mike Gonsalves. No						
additional information was provided by LMA. (DWR UCIP – O. Magana)						
03/06/2013 Need to coordinate with owner to determine status of						
crossing--unable to locate in field. (DWR UCIP - O. Magana)						
FIELD_STRUCT_DESC: 18-inch drainage pipe of unknown material						
through the levee at an unknown depth below the levee crown. Crossing						
information was obtained from Sacramento County GIS records.						
FS Date: 3/6/2013

Approximate alignment of crossing provided by the City of Sacramento.

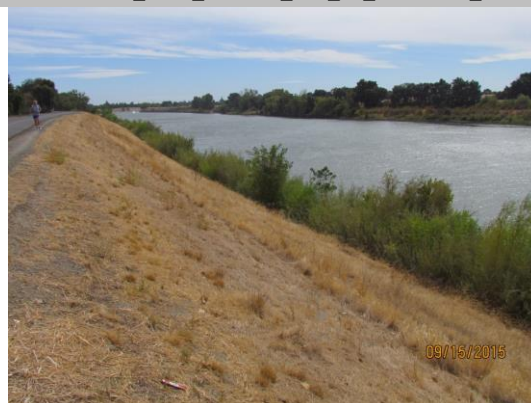
Photo 1 of 2 : SP\_2018\_NA0005\_251\_21\_20180319\_00010.jpg

LM Start	2.46	Rating **	A/W	Issue No.	21
LM End	2.75	Issue Type +	Ob	Location *	WS
Category	Earthen Levee			GPS Latitude/Longitude	
				Start	End
Item	Vegetation			38.557828 °	38.553710 °
				-121.514193 °	-121.512863 °
DWR ID	DWR_NA0005_01_s _ 2012_21				
Comment Code					
V8 : Environmental Requirements.					
Inspector Comment					
Revegetation site is at the toe of the levee on the waterward side.

View of the revegetation site on the waterward side looking downstream.  
Fall 2015.

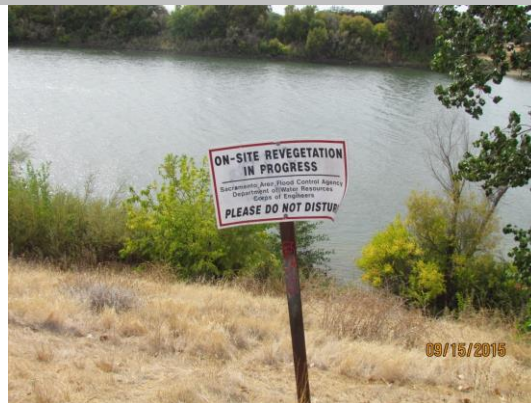
Photo 2 of 2 : SP\_2018\_NA0005\_251\_21\_20180319\_00011.jpg

LM Start	2.46	Rating **	A/W	Issue No.	21 (cont)	
LM End	2.75	Issue Type +	Ob	Location *	WS	
Category	Earthen Levee			GPS Latitude/Longitude		
				Start		End
Item	Vegetation			38.557828 °		38.553710 °
				-121.514193 °		-121.512863 °
DWR ID	DWR_NA0005_01_s_2012_21					
Comment Code						
V8 : Environmental Requirements.						
Inspector Comment						
Revegetation site is at the toe of the levee on the waterward side.

This area is a revegetation site. Fall 2015.

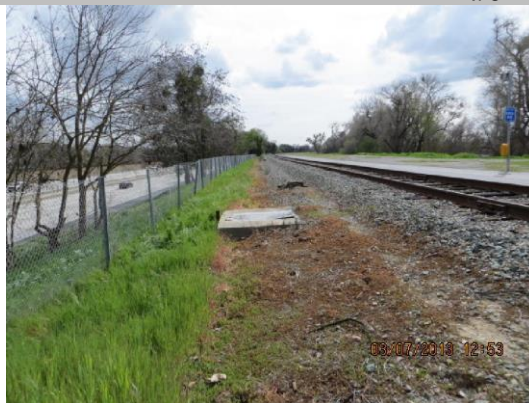
Photo 1 of 3 : UCIP\_SP\_2018\_52603\_59534.jpg

Comment Code						
Inspector Comment						
FS_ID:52603 DS_ID:21578 EP_NO: 2043 Repair Type: Non-Urgent Crossing Status: Found UCIP Comments: 07/21/2016 Meet with City of Sacramento North Area Drainage representatives: Mick Smith and Mike Gonsalves. Crossing is not abandoned. The City of Sacramento is currently working at trying to refurbish the Ranney Collector site. According to LMA, pipe is a 30-inch and not a 24-inch pipe. Pipe size and system description updated to reflect LMAs records. This pipe is linked to the USACE's PI issue USACE_CESPK_SACD_2013_a_0211. (DWR UCIP – O. Magana) 03/07/2013 This crossing has been abandoned. According to City of Sacramento Staff the last time this crossing was fired up to see if it was functioning was 3 years ago. Recommend owner coordinating with Central Valley Flood Protection Board (CVFPB) to abandon facility per Title 23. (DWR UCIP - O. Magana) FIELD_STRUCT_DESC: [Ranney Collector] 30-inch discharge pipe through levee at an unknown depth below the levee crown. Collector system located on waterside (WS) slope. (construct one Ranney Water Collector authorized under Permit No. 2043, 1955 - City of Sacramento). [Additional Reference(s): DWR Levee Log, 1993] FS Date: 3/7/2013

LM Start	<b>2.89</b>	Rating **	M	Issue No.	<b>160 (cont)</b>
LM End	<b>2.89</b>	Issue Type +	En	Location *

Concrete vault located on landward shoulder.

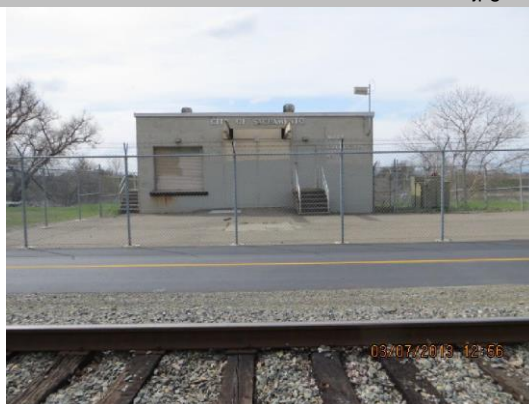
Photo 2 of 3 : UCIP\_SP\_2018\_52603\_59532.jpg

Ranney collector facility operated by the City of Sacramento.

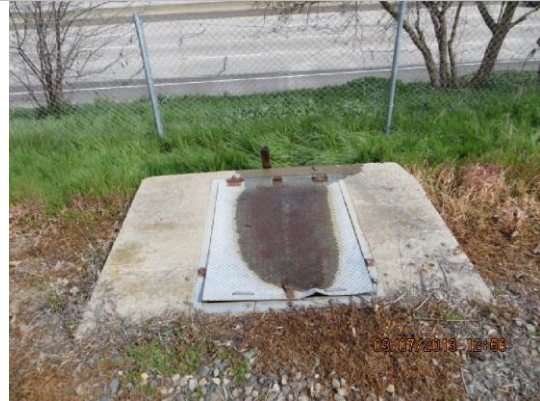
Photo 3 of 3 : UCIP\_SP\_2018\_52603\_59531.jpg

Comment Code						
Inspector Comment						
FS_ID:52603 DS_ID:21578 EP_NO: 2043 Repair Type: Non-Urgent Crossing Status: Found UCIP Comments: 07/21/2016 Meet with City of Sacramento North Area Drainage representatives: Mick Smith and Mike Gonsalves. Crossing is not abandoned. The City of Sacramento is currently working at trying to refurbish the Ranney Collector site. According to LMA, pipe is a 30-inch and not a 24-inch pipe. Pipe size and system description updated to reflect LMAs records. This pipe is linked to the USACE's PI issue USACE_CESPK_SACD_2013_a_0211. (DWR UCIP – O. Magana) 03/07/2013 This crossing has been abandoned. According to City of Sacramento Staff the last time this crossing was fired up to see if it was functioning was 3 years ago. Recommend owner coordinating with Central Valley Flood Protection Board (CVFPB) to abandon facility per Title 23. (DWR UCIP - O. Magana) FIELD_STRUCT_DESC: [Ranney Collector] 30-inch discharge pipe through levee at an unknown depth below the levee crown. Collector system located on waterside (WS) slope. (construct one Ranney Water Collector authorized under Permit No. 2043, 1955 - City of Sacramento). [Additional Reference(s): DWR Levee Log, 1993] FS Date: 3/7/2013

Close up view of vault located on landward levee shoulder.
